2005 PALLADIO AWARDS

Stable R&R

PROJECT: ALAN H. REED ESTATE STABLE, WAYNE, PA

ARCHITECT: ARCHER & BUCHANAN ARCHITECTURE, LTD., WEST CHESTER, PA; PETER C. ARCHER, AIA, PRINCIPAL; MARK AVELLINO, PROJECT MANAGER

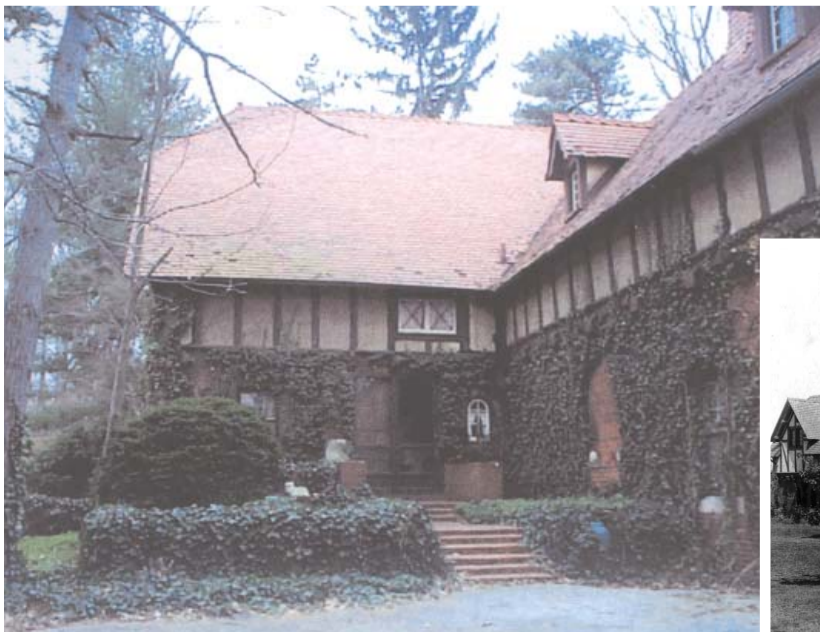
Far left: Before the renovation, the house was severely deteriorated, with 25% of the roof tile failing, damaged brick and rotted woodwork.

Because of the age, lack of maintenance and the condition of the house, many materials and details needed to be replaced or reconstructed. On the roof, about 75% of the red clay tile was salvageable, with the remainder lost due to breakage or cracking. “We removed the tile, replaced the sheathing and copper flashings and reinstalled the tile,” says Archer. Samples of the tile were matched and split in to blend the new with the old. Wood exterior trim and dormers that had rotted were replaced with mahogany and painted. The brick was repointed, matching the salmon color of the original mortar. Salvaged brick from newly created openings was used in places where the brick had to be replaced. Except for those in the arched openings, the windows were all replaced. “The windows were damaged and not of great quality,” he says. “Several had been replaced since the original construction.”

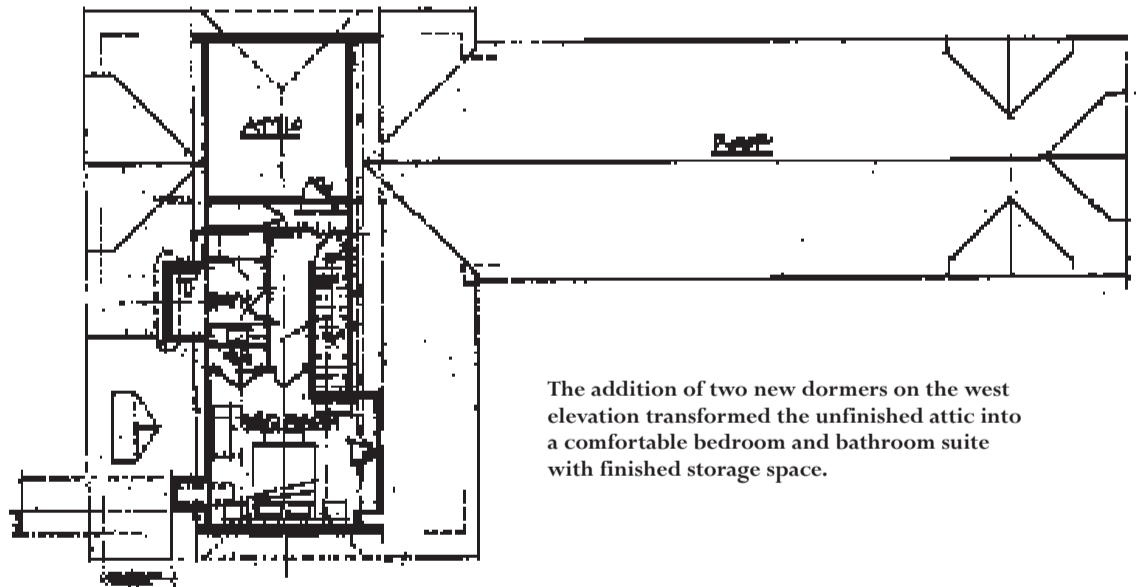
The addition of two new dormers on the west elevation transformed the unfinished attic into a comfortable bedroom and bathroom suite with finished storage space.

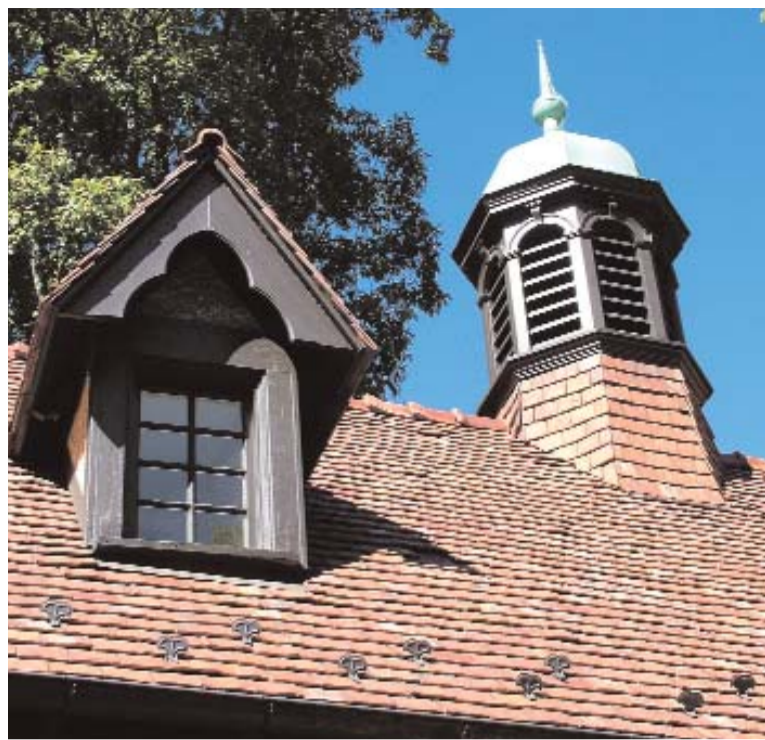
Two new dormers were added for extra light. They were designed to fit into the style without mimicking the originals. The cupola required extensive reconstruction – 25% of the woodwork was replaced and then painted to match what remained.
